DEPARTMENT OF TRANSPORTATION**DIVISION OF ENGINEERING SERVICES**

Office of Structural Materials

Contract #: 04-0120F4Cty: SF/ALA Rte: 80 PM: 13.2/13.9File #: 70.28**WELDING INSPECTION REPORT****Resident Engineer:**Pursell, Gary**Address:** 333 Burma Road**City:** Oakland, CA 94607**Report No:** WIR-004162**Date Inspected:** 20-Oct-2008**Project Name:** SAS Superstructure**OSM Arrival Time:** 2200**Prime Contractor:** American Bridge/Fluor Enterprises, a JV**OSM Departure Time:** 800**Contractor:** Japan Steel Works**Location:** Muroran, Japan**CWI Name:** Makhmud Ashadi**CWI Present:** Yes No**Inspected CWI report:** Yes No N/A**Rod Oven in Use:** Yes No N/A**Electrode to specification:** Yes No N/A**Weld Procedures Followed:** Yes No N/A**Qualified Welders:** Yes No N/A**Verified Joint Fit-up:** Yes No N/A**Approved Drawings:** Yes No N/A**Approved WPS:** Yes No N/A**Delayed / Cancelled:** Yes No N/A**Bridge No:** 34-0006**Component:** Tower, Deviation and Jacking Saddles**Summary of Items Observed:**

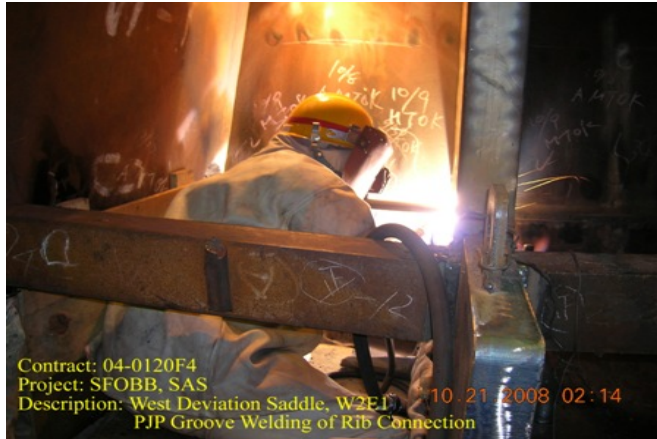
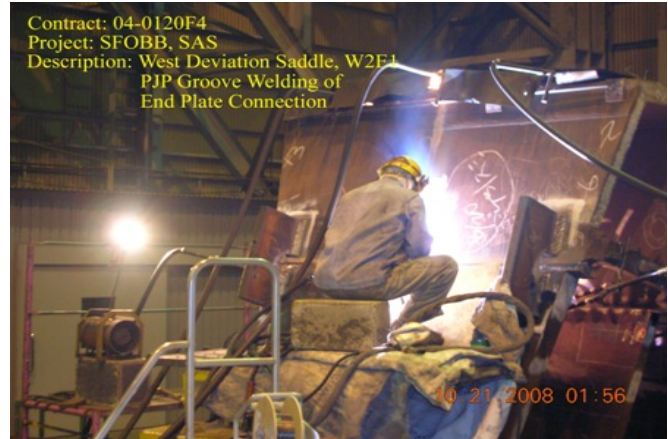
The PJP groove welding was performed on the structural steel rib to casting rib connections identified as E1Y-9U, E1Y-11U, E1Y-12U and E1Y-17U-2.

See Weld Joints in Progress Inspected on page 3 of this report in regards to QA observation of the welding parameters recorded during this shift and the digital photographs which illustrates the observations of the activities performed on this date.
